**FAC – Lower Water Street Roof Replacement
U&U**

UARB APPROVAL SHEET

ROOF CONDITION ASSESSMENT REPORT

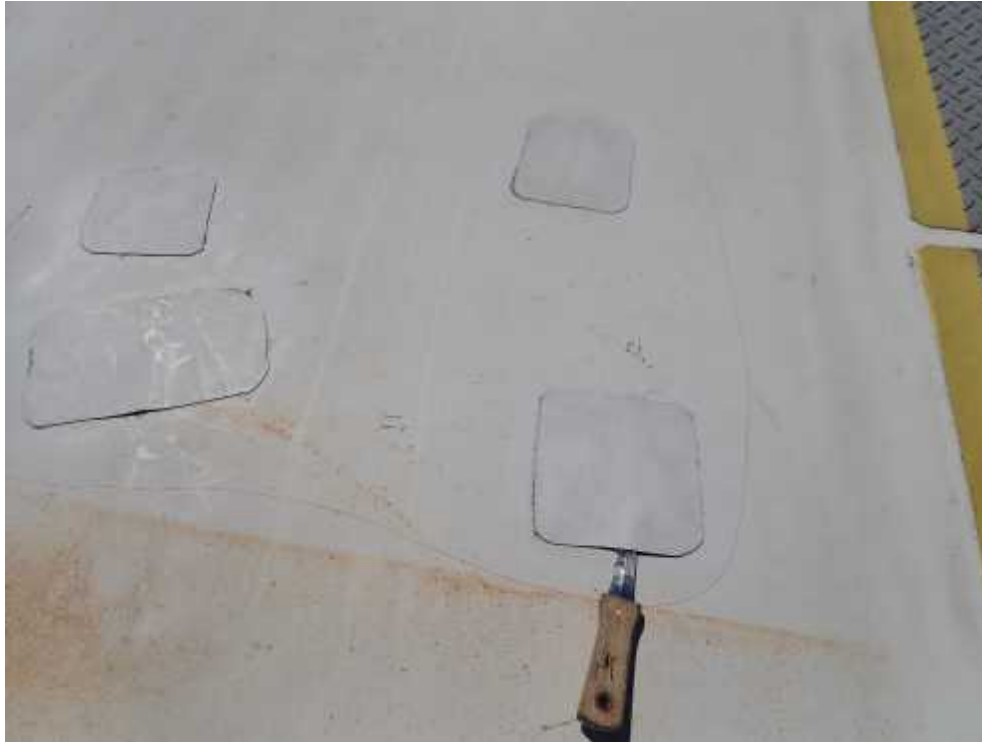
Photograph 39: Roof Area 2.1 – Poor heat welding at previous patch repairs. Membrane separation is evident.

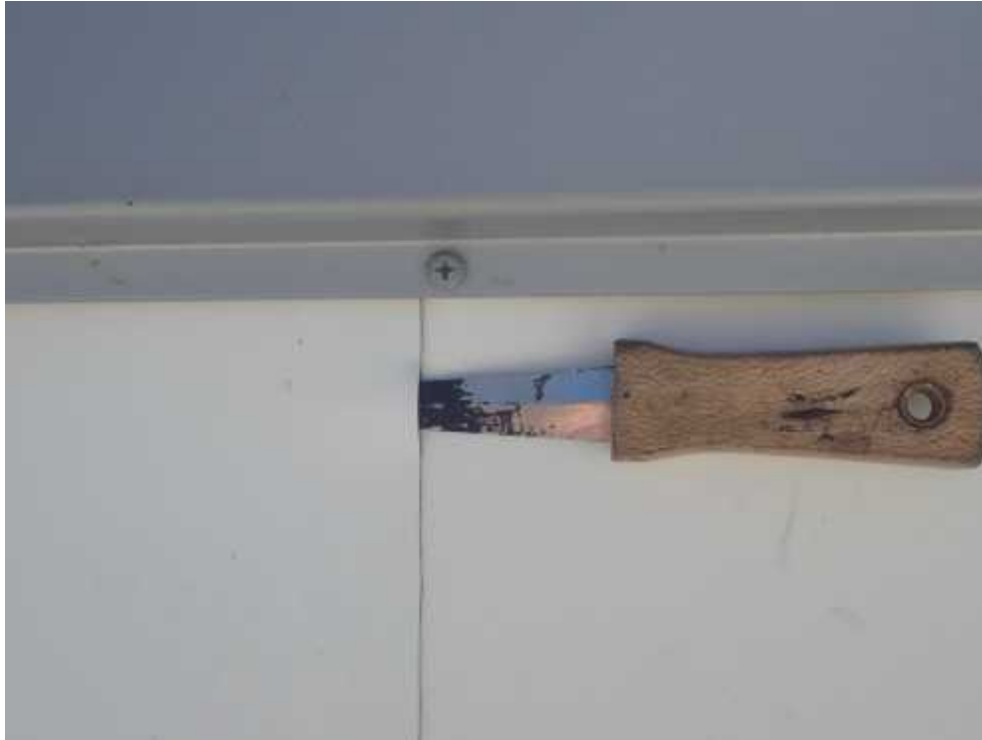
Photograph 40: Roof Area 2.1 – east wall – membrane separation at one location.

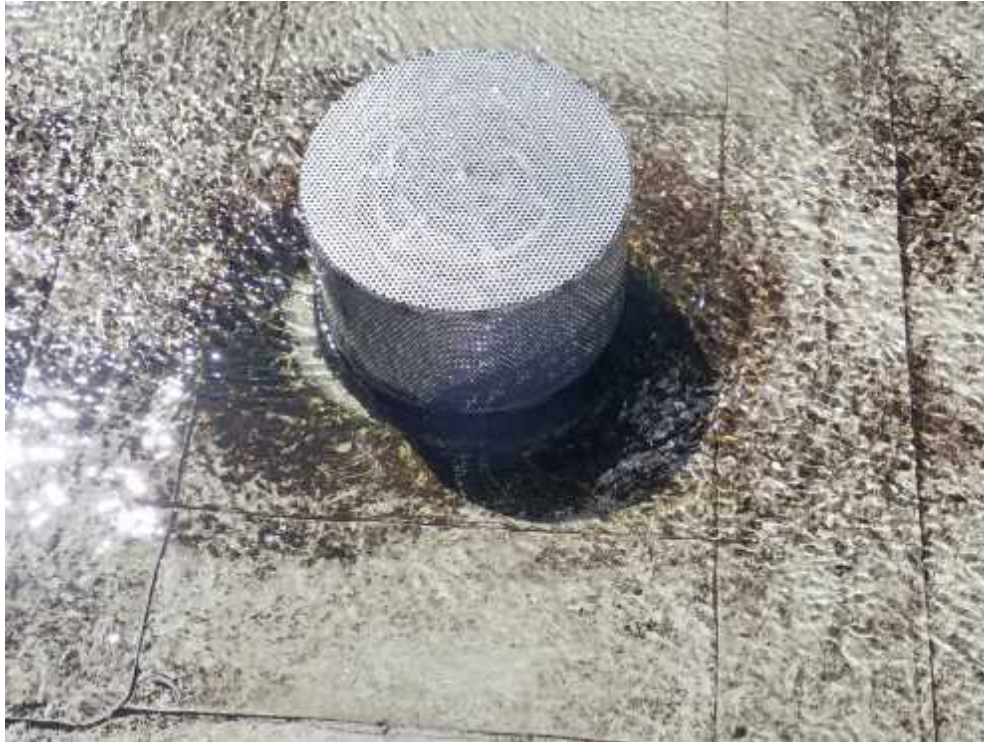
Photograph 41: Roof Area 2.1 – debris present around the drain. Ponding water is present due to slower drain times.

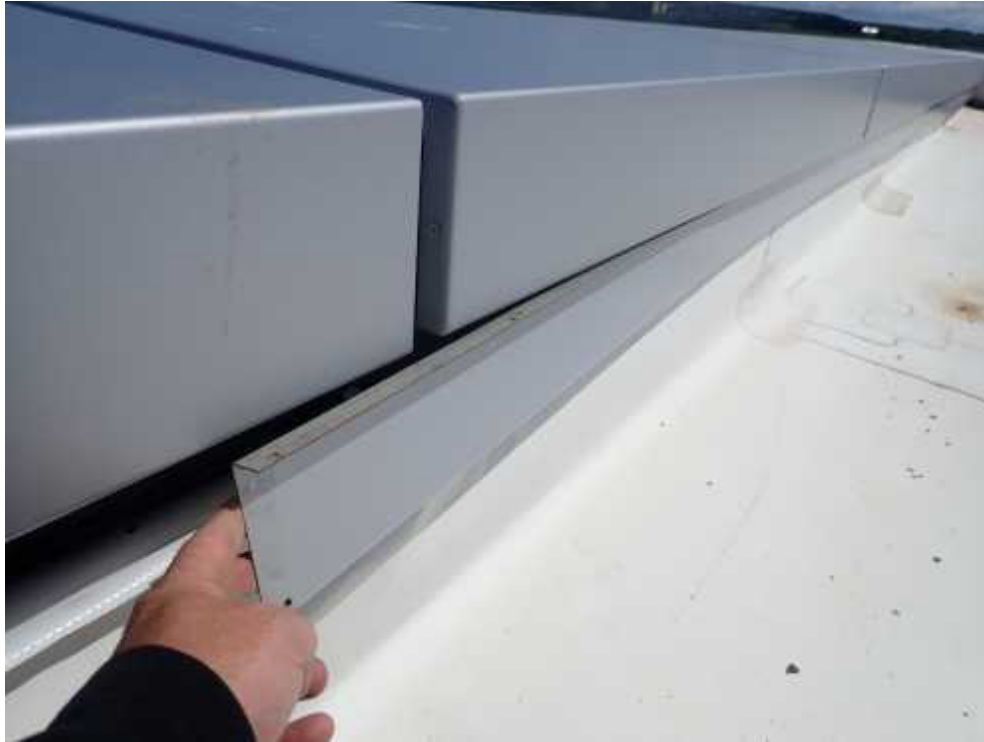
Photograph 42: Roof Area 2.1 – poorly secured counterflashing at the roof perimeter.

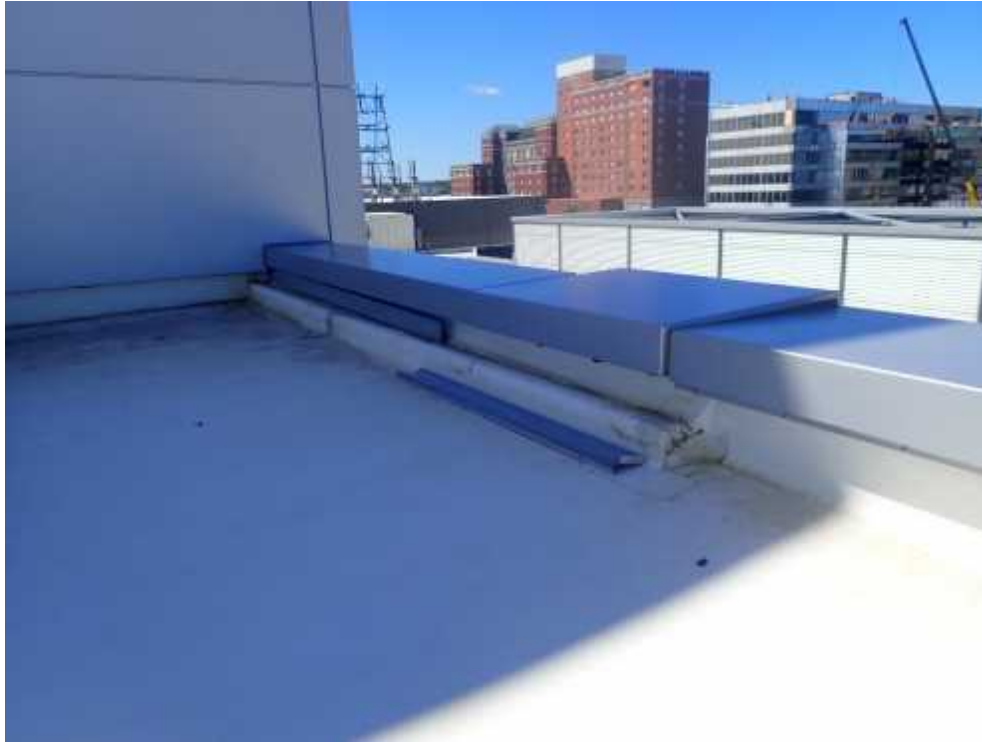
Photograph 43: Roof Area 2.1 – poorly secured counterflashing and loose counterflashing along the roof perimeter.

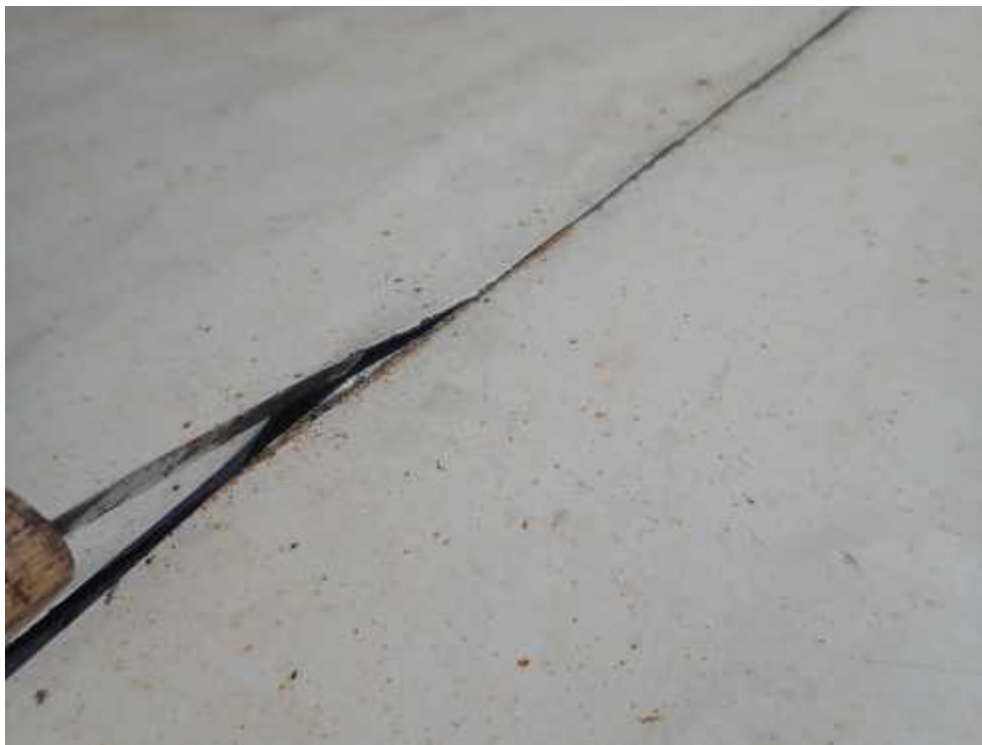
Photograph 46: Roof Area 3.1 – east side of roof area – poorly welded seam. Membrane is not adhered fully.

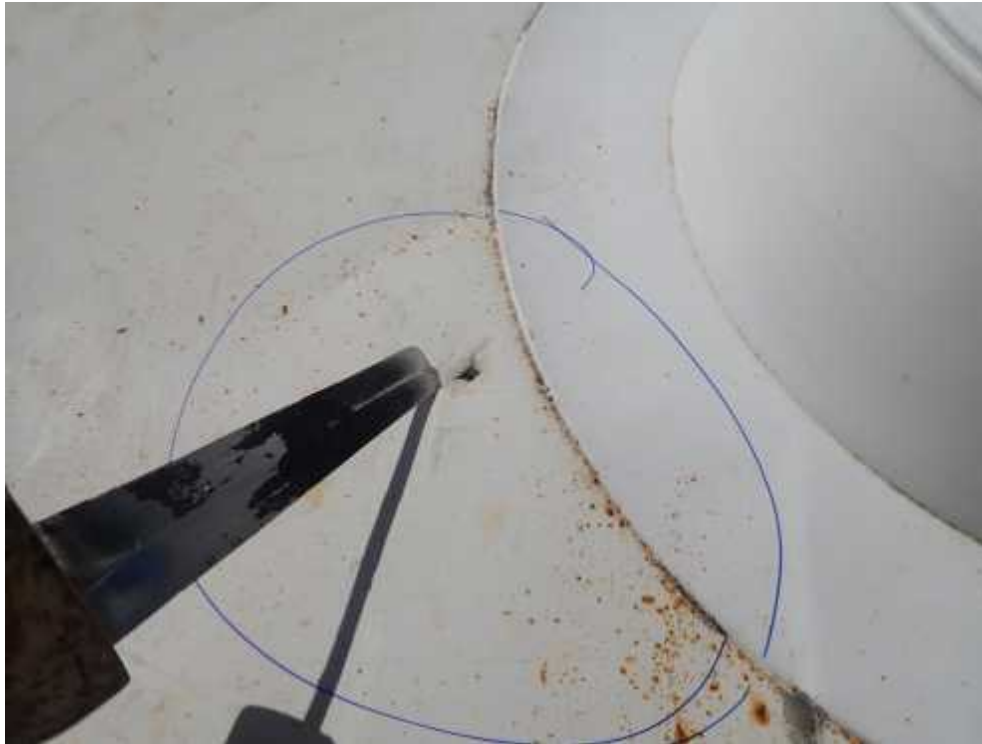
Photograph 47: Roof Area 3.1 – membrane puncture on east side of roof.

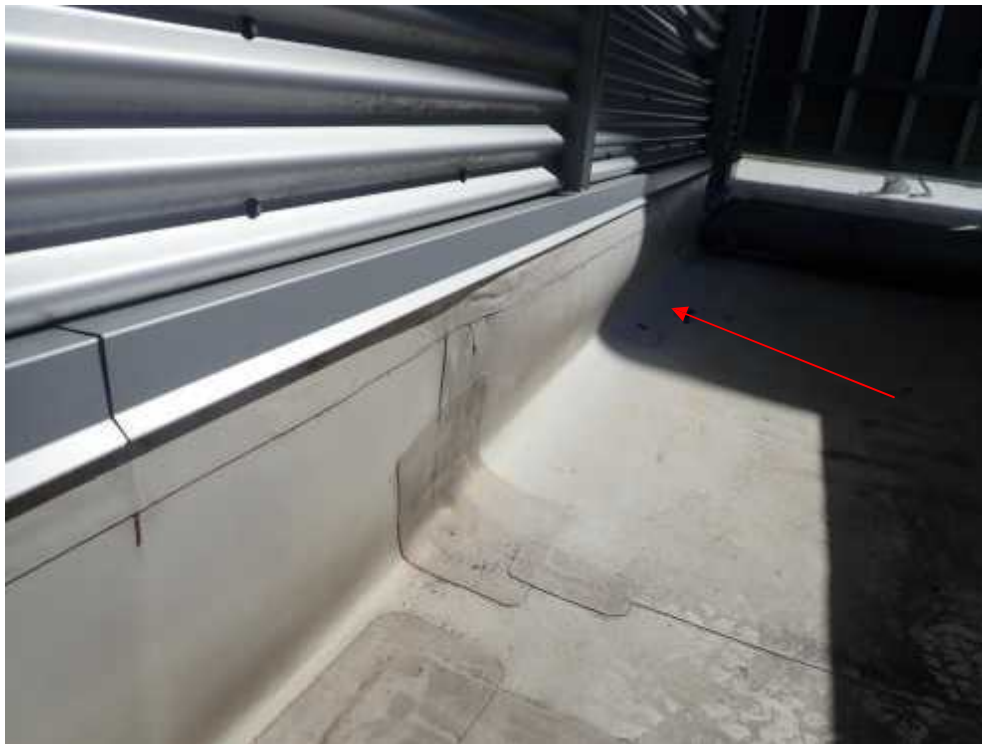
Photograph 48: Roof Area 1.2 – the seam is not fully sealed at this location at the perimeter wall.

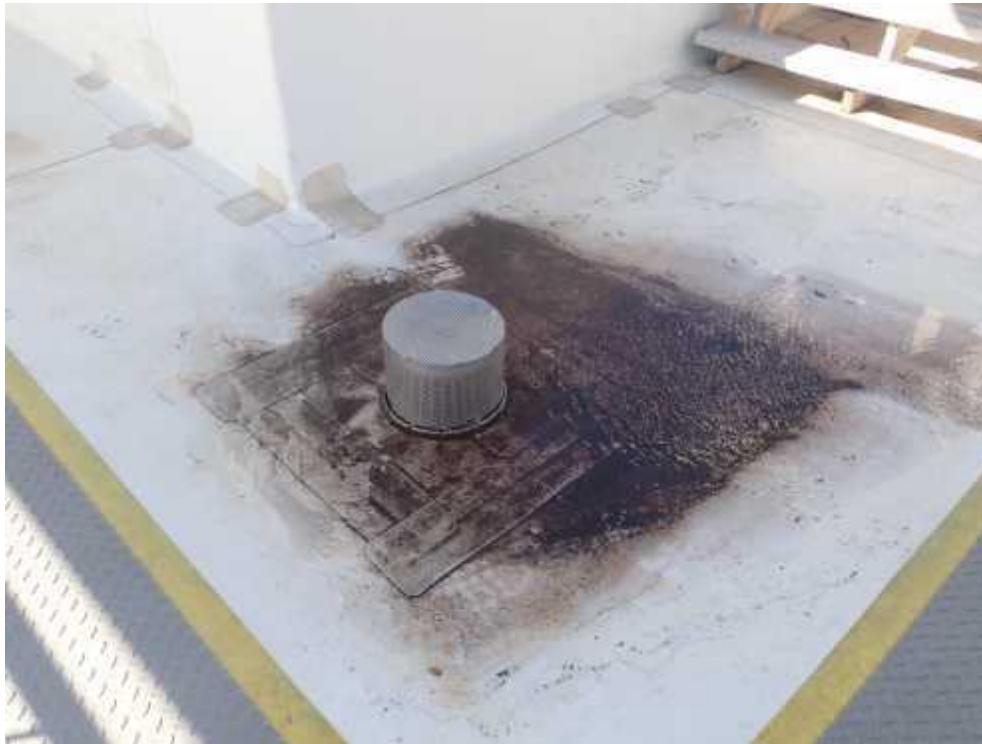
Photograph 49: Roof Area 3.1 – Debris present around the drain which slows the draining process. Water is present at this roof drain.

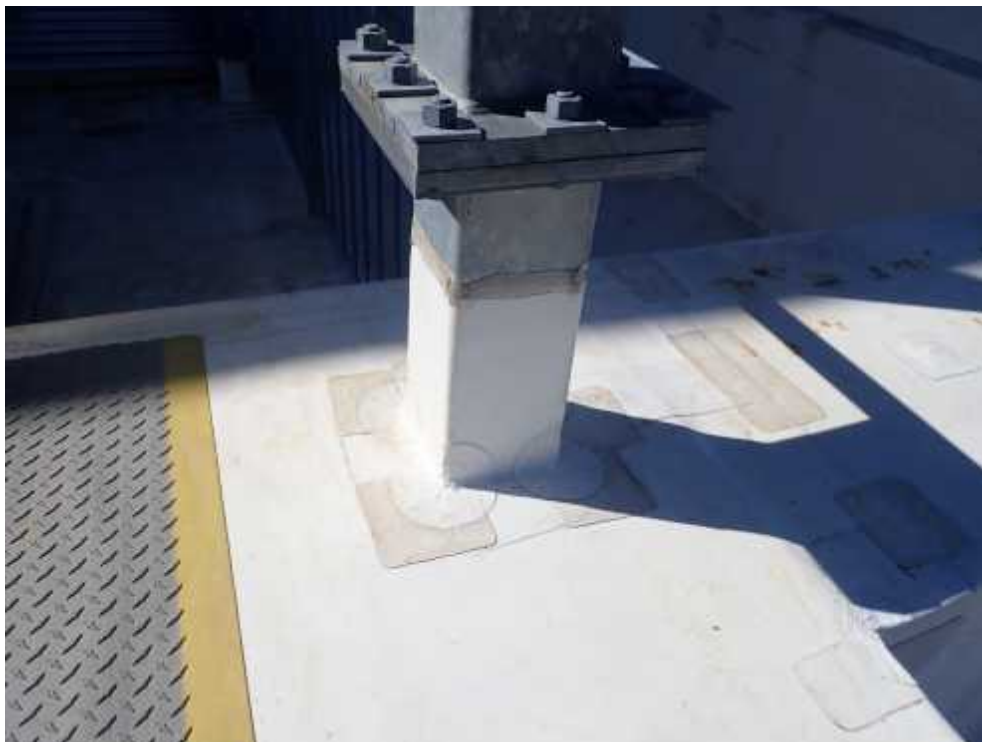
Photograph 50: Roof Area 3.1 – Poor sealant joint and no securement straps at the base of the support posts. Typical.

7. Missing securement straps are evident around the support post in multiple locations. (Photograph 50).
8. Missing metal flashings are evident on the west side in one area. Improperly sealed membrane is also evident in this location. Improperly secured metal flashings are also evident in various areas around the perimeter walls. (Photograph 51 and 52).

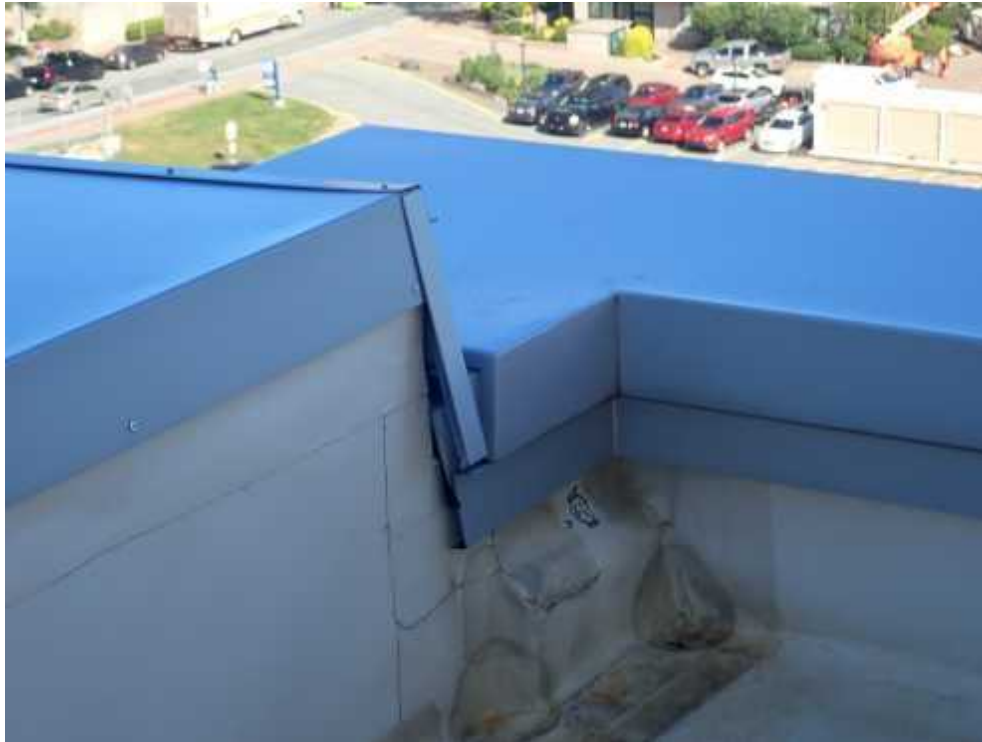
Photograph 51: Roof Area 3.1 – Loose flashings at the perimeter wall location.

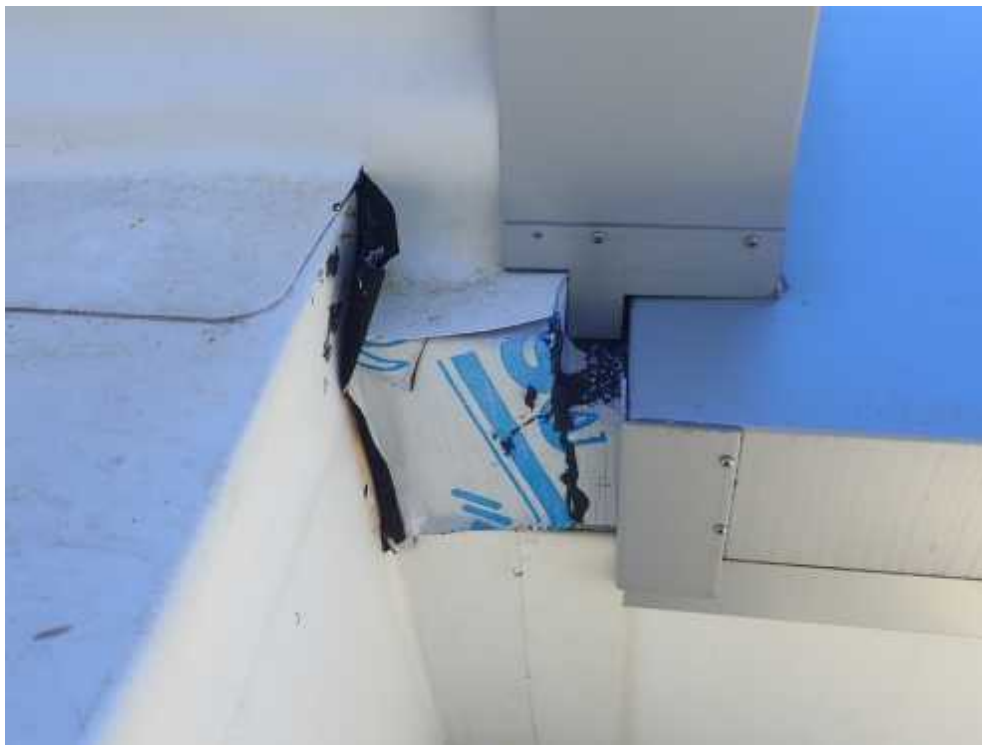
Photograph 52: Roof Area 3.1 – improperly sealed membrane on the west side of roof area 3.1

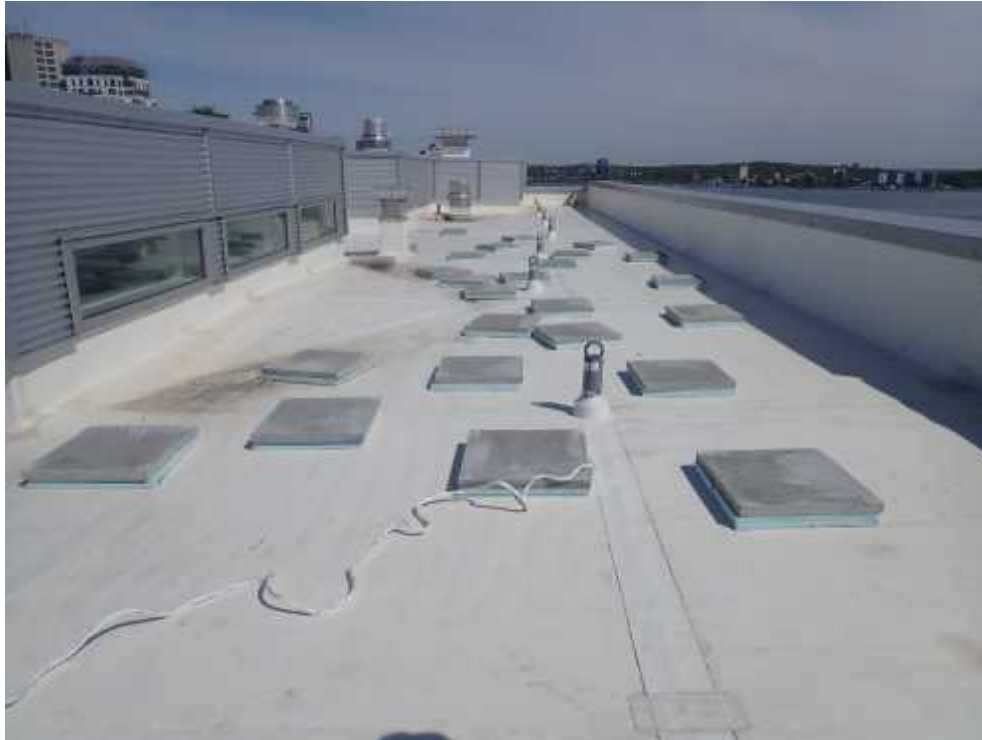
Photograph 55: Roof Area 4.1 – Previous wind damage observed. The membrane is fully separated from the underlayment board.

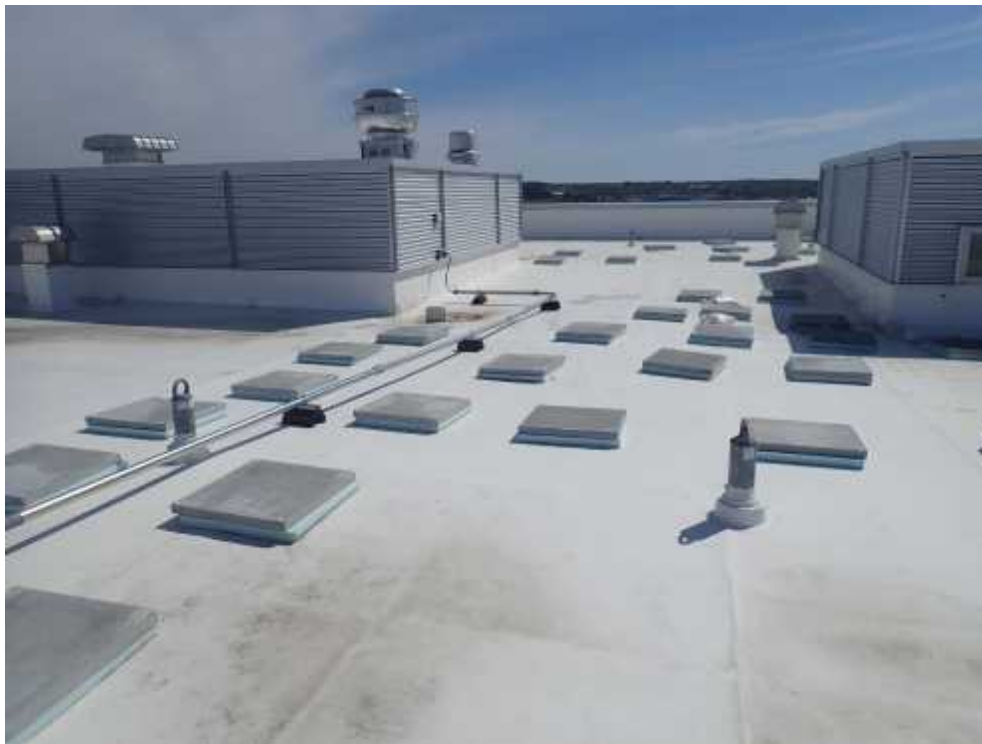
Photograph 56: Roof Area 4.1 - Previous wind damage observed. The membrane is fully separated from the underlayment board.

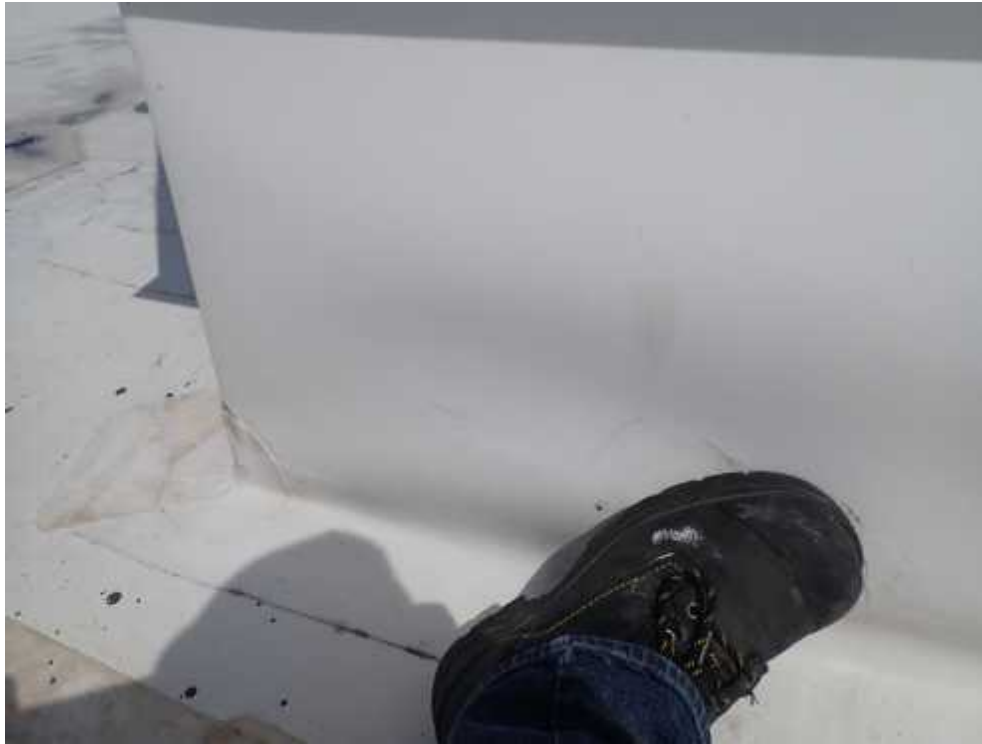
Photograph 57: Roof Area 4.1 – Membrane tenting at the roof perimeter has occurred.

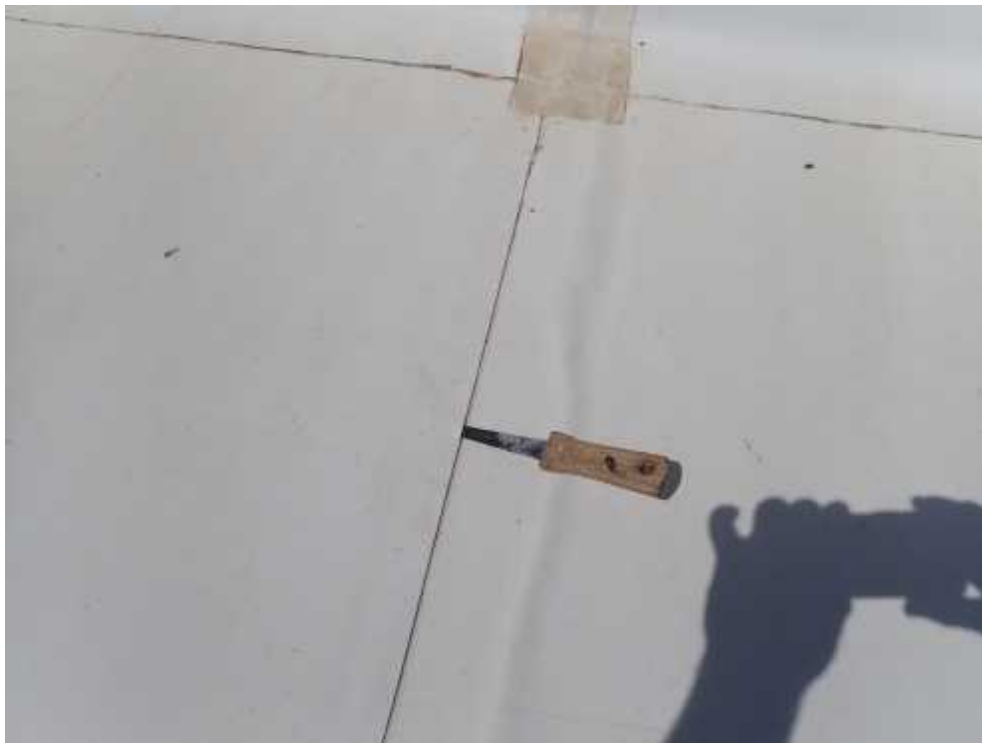
Photograph 58: Roof Area 4.1 – Seam is not fully sealed.

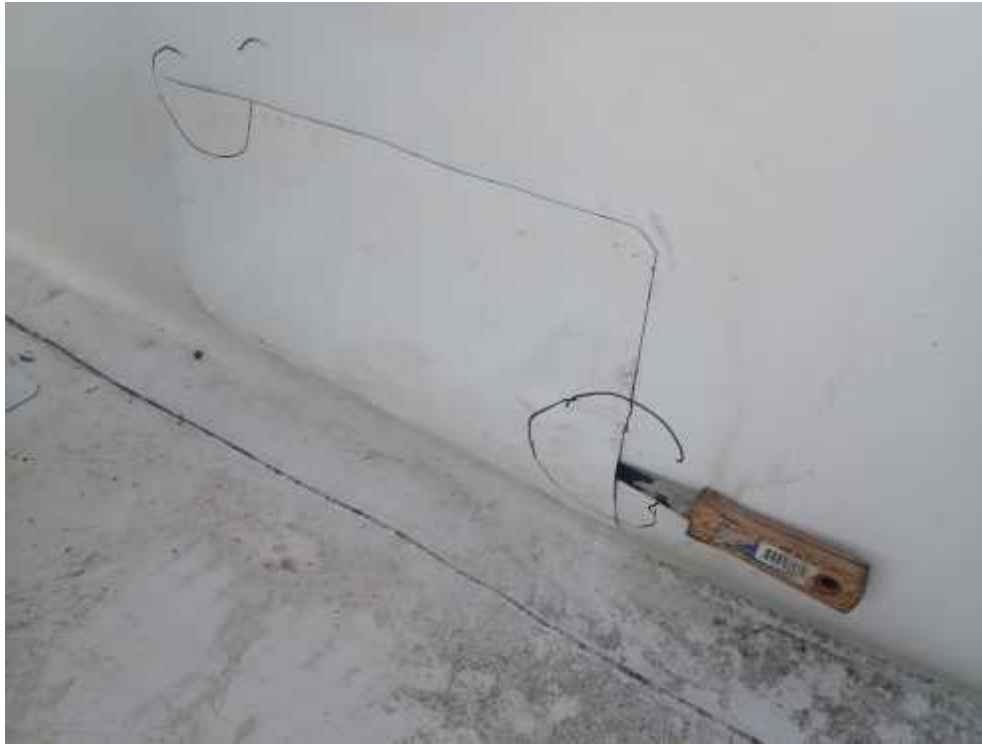
Photograph 59: Roof Area 4.1 – Poor heat welding has resulted in separation of the seams at this location. .

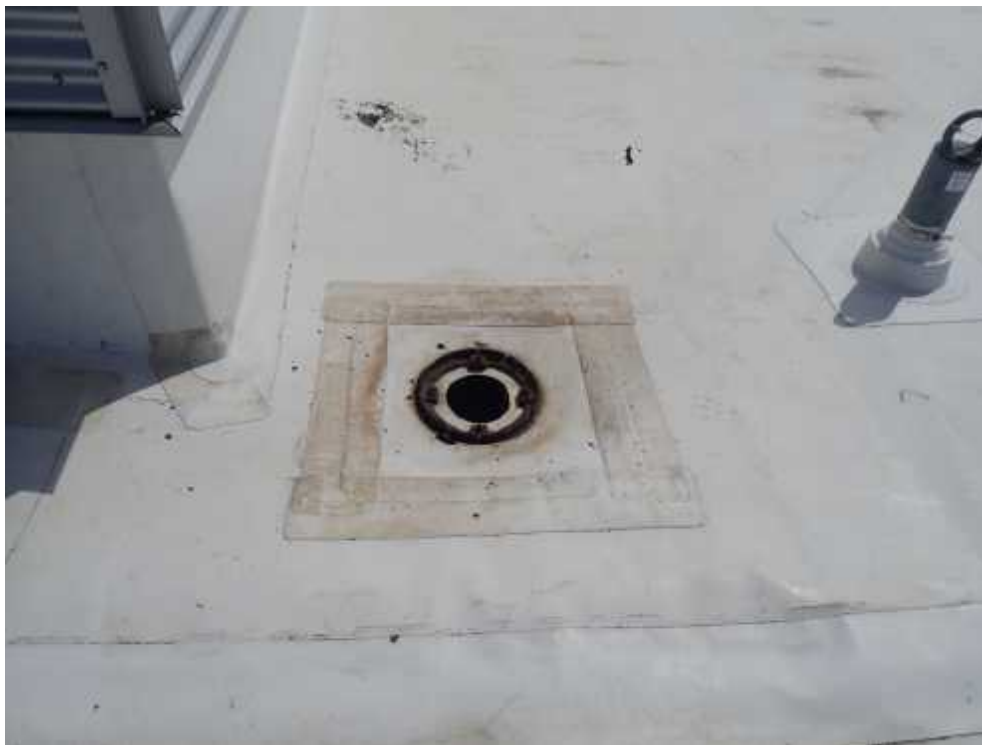
Photograph 60: Roof Area 4.1 – Missing drain strainer adjacent to upturn wall of roof area 5.2.

1. The existing membrane has suffered significant wind damage in a previous wind storm and is now fully separated from the recovery board on approximately 1/2 of the roof. Pavers have been installed to hold the existing membrane in place until repairs/replacement is completed. (Photograph 55 and 56).
2. The fully bonded TPO membrane around the curbs and perimeter walls has also fully separated in multiple areas causing excessive membrane tenting to occur. (Photograph 57).
3. Excessive membrane tenting is also evident on the field of the roof in multiple areas.
4. There are multiple locations where the TPO membrane seams are not fully sealed on the field and at up turn/detail locations, due to inconsistent heat welding/ patching. (Photograph 58 and 59).
5. One existing drain strainer is missing or out of place. (Photograph 60).

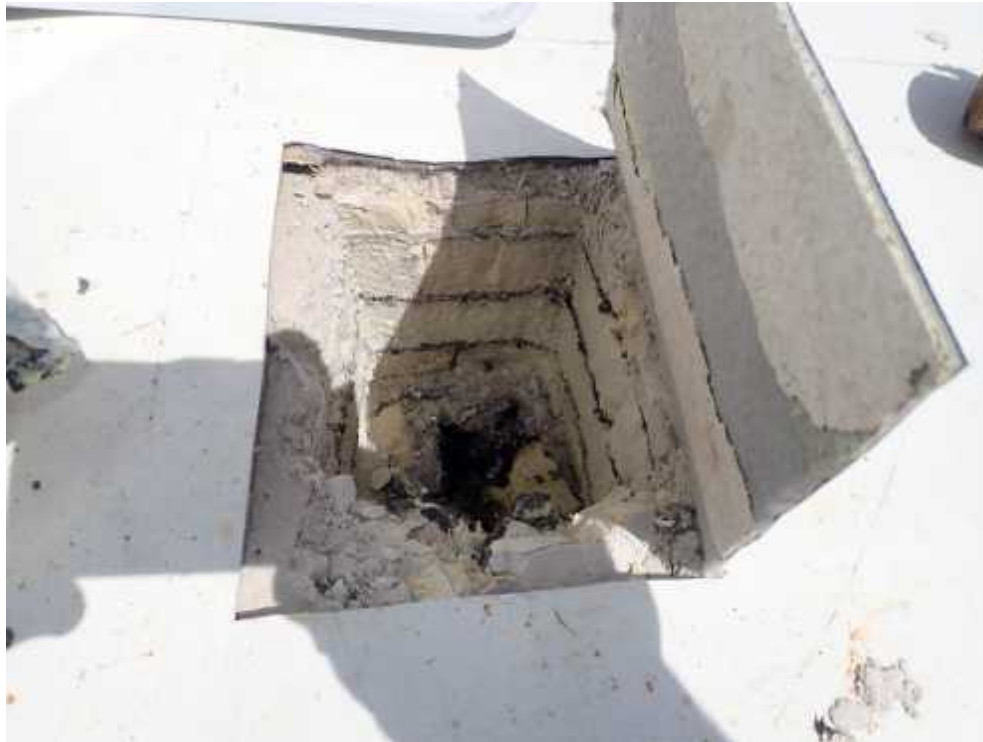
Photograph 61: Roof Area 4.1 – Cut test area number 1.

6. Cut test revealed excessive moisture on the walls and on the field in multiple areas. The moisture has fully saturated the underlayment board causing membrane failure. (Photograph 61 and 62).
7. It is believed that moisture got below the membrane, causing the Dense Deck underlayment board to become saturated with water. This has caused membrane separation between the adhesive holding the TPO in place and recovery board. Due to high winds the membrane is now fully separated and requires immediate replacement. (Photograph 63).

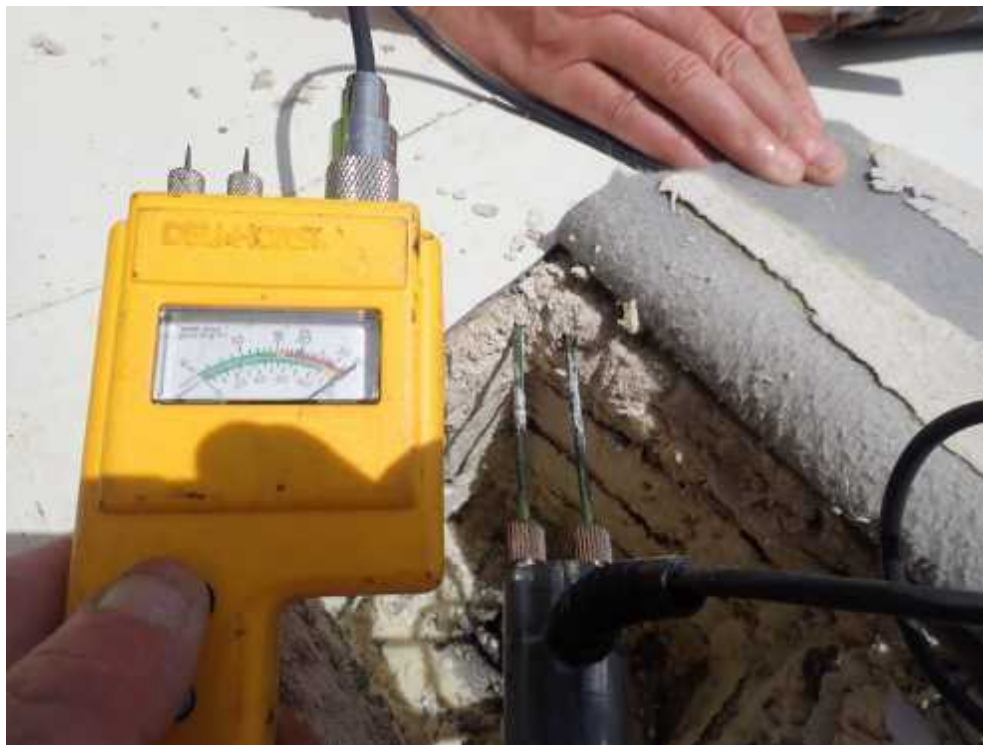
Photograph 62: Roof Area 4.1 – cut test location number 1, underlayment board contains excessive amounts of water.

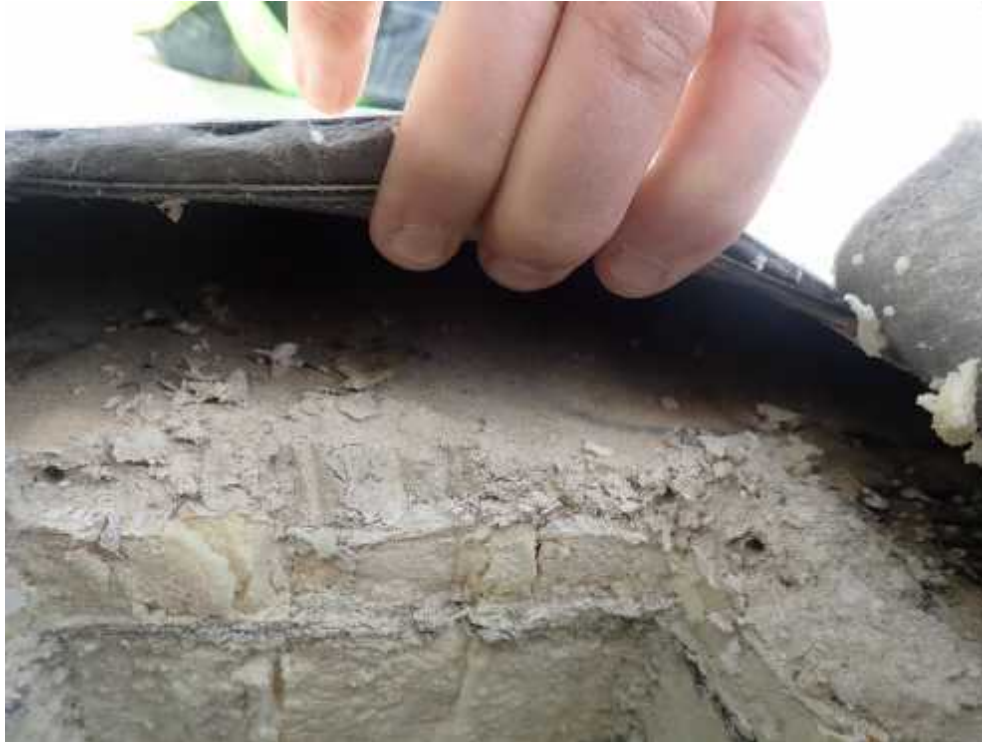
Photograph 63: Roof Area 4.1 – Cut test location 1 – membrane adhesion to the underlayment board has failed.

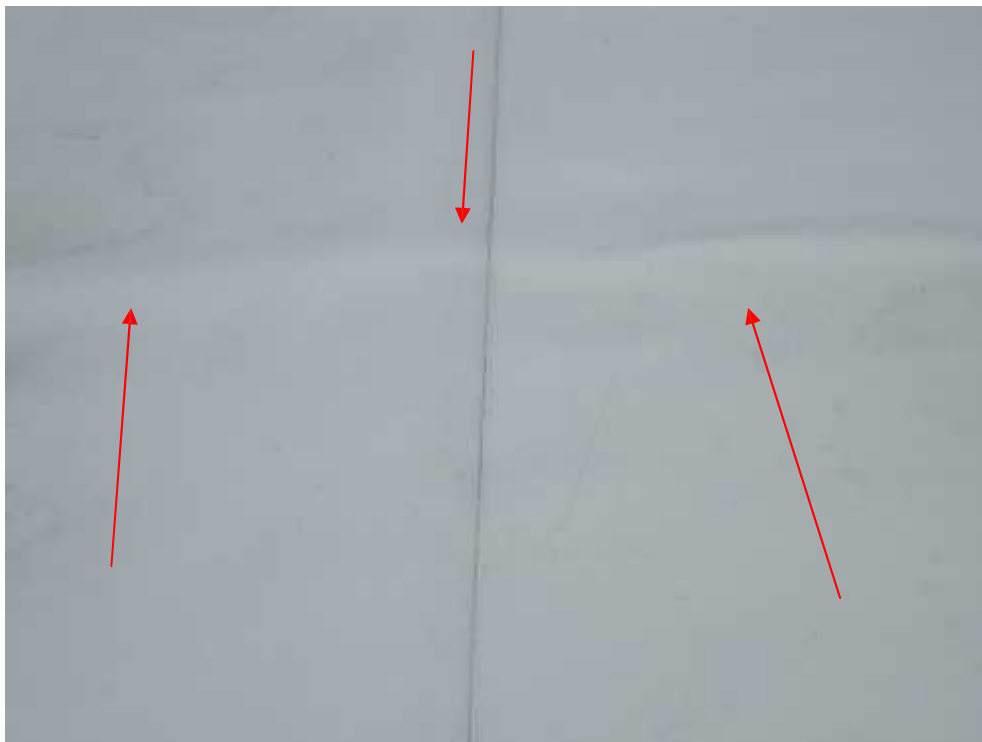
Photograph 66: Roof Area 5.1 – Membrane tenting in the field of the roof.

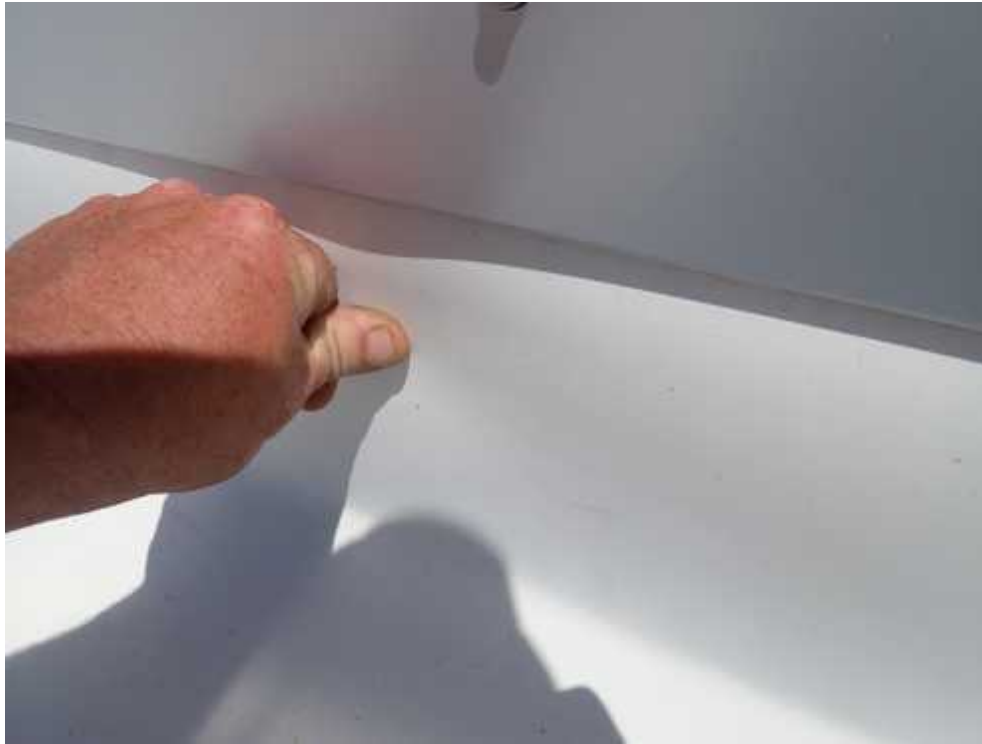
Photograph 67: Roof Area 5.1 – Membrane tenting at the perimeter of the roof.

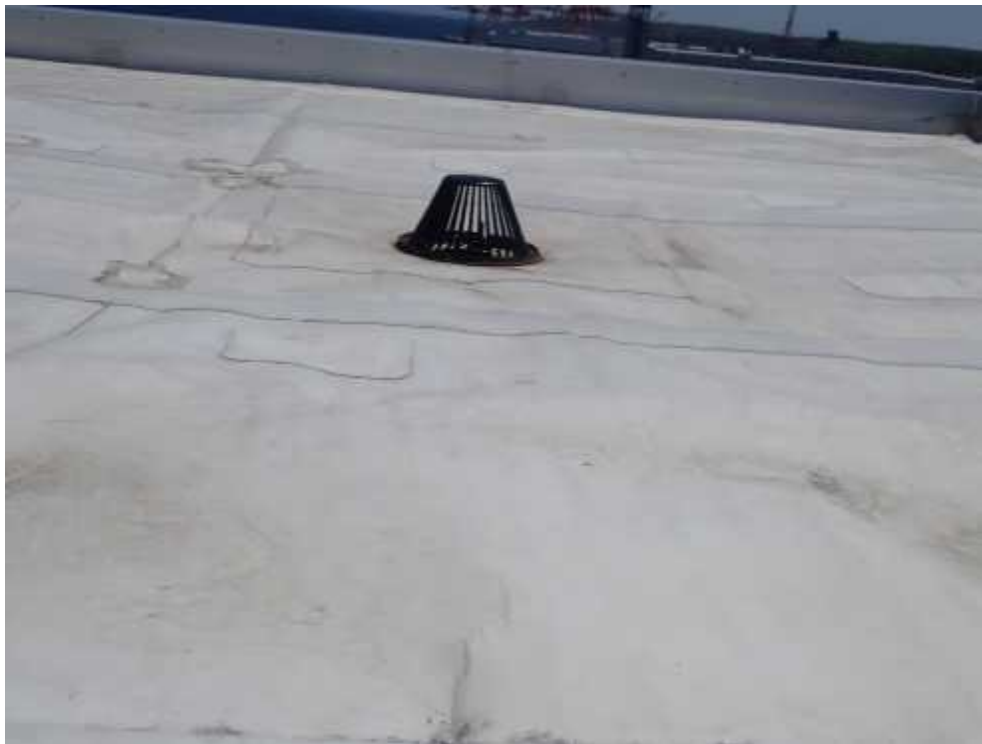
Photograph 70: Roof Area 5.2 – Multiple ridges and tenting visible, membrane is not adhered to the underlayment board.

1. The existing membrane has suffered significant wind damage in a previous wind storm and is now fully separated from the recovery board on the entire roof area. (Photograph 70).

4. It is believed that moisture got below the membrane, causing the Dens Deck recovery board to become saturated with water. This has caused membrane separation between the adhesive holding the TPO in place and recovery board. Due to high winds the membrane is now fully separated and requires immediate replacement.

1. Replace all roofs where wind damage was observed. The extent of saturated insulation is unknown. Further investigation on the insulation is recommended prior to replacement.
2. Roof areas requiring replacement; 1.1, 1.2, 1.3, 4.1 and 5.2. This work should be carried out within the next 0-1 years.
3. Implement a new 2-ply roof system to better withstand freeze-thaw cycles. The existing 1-ply TPO roofing system is not adequate for Atlantic Canada's climate.

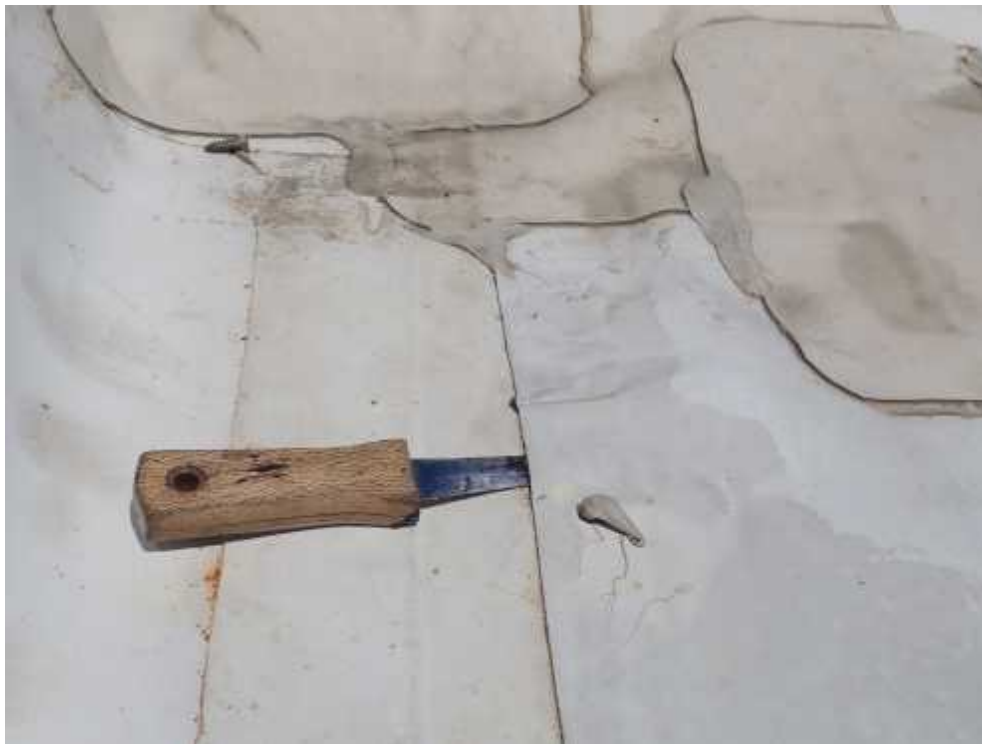
Photograph 72: Roof Area 5.2 – Membrane tenting in the field of the roof.

3. There are multiple locations where the TPO membrane seams are improperly sealed on the field and around the detail, due to inconsistent heat welding/ patching. (Photograph 72).
